Sparkplug reading observations by Bruce Robertson. www.smartcarby.com

This is about performance tuning not tuning for emissions or maximum economy, strictly racing here. This is about tuning on the rich side of stoichiometric. It is impossible to separate sparkplug deposits from the subject of vaporization.

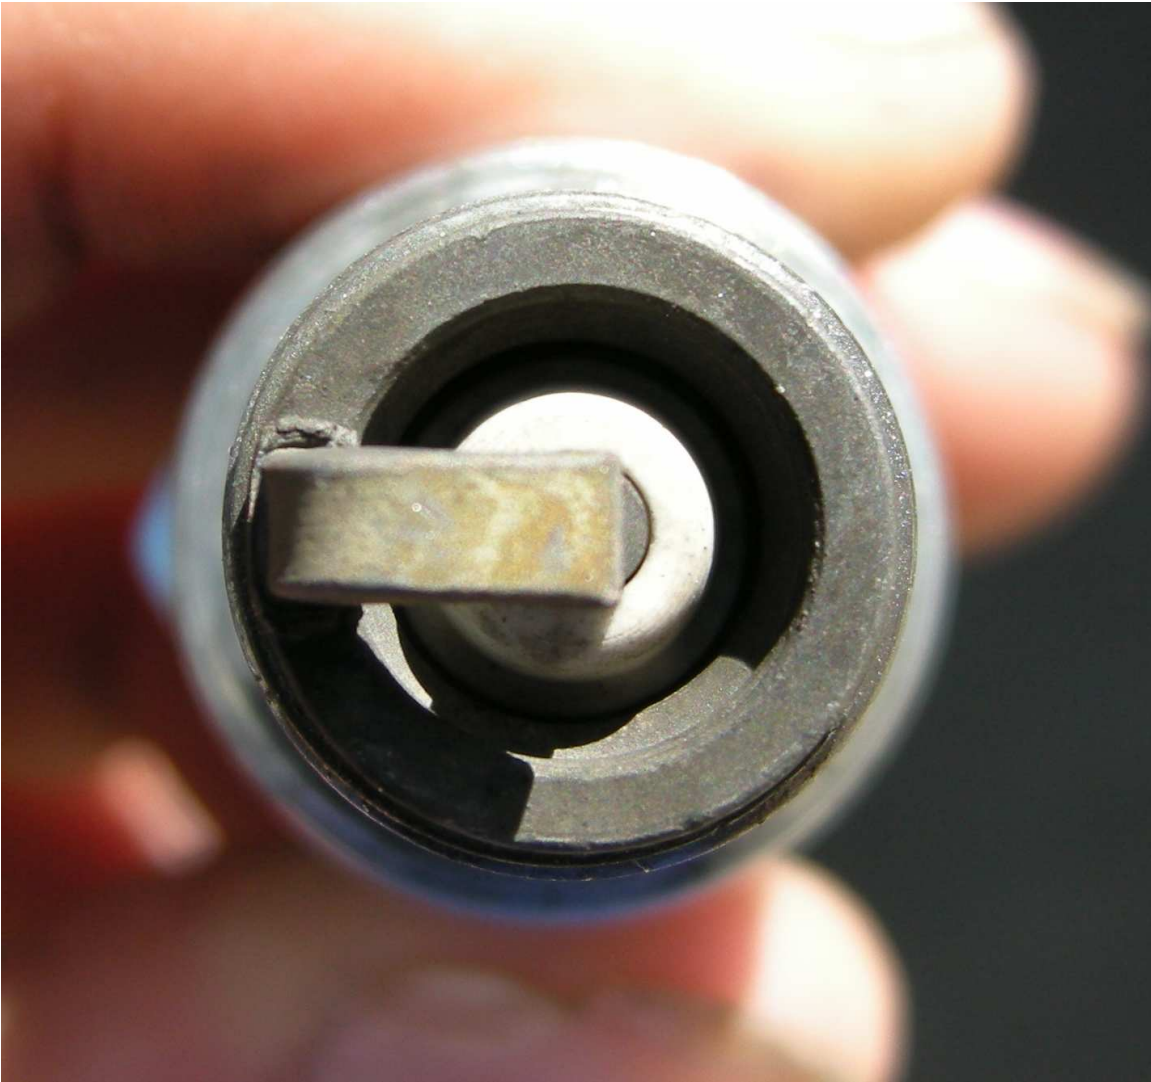
This plug is very interesting. The stripe effect on the strap electrode shows the various colours that normally get deposited. There are areas of no deposit, areas of white and areas of brown. It is interesting how the deposits are forming in stripes. The engine that formed this plug is an alcohol - supercharged Keith Black 526. It was burning lean. So lean that if they richened it up at all it melted the sparkplugs. The striped zones of different colouration are possibly happening from a flame kernel that is erratic in its growth rate. This is what I would expect to happen if the mixture is too lean. There is not enough heat to maintain consistent flame growth. The fireball is depositing the brown areas where the HC concentration is highest then it is depositing the white in the areas that are leaner.

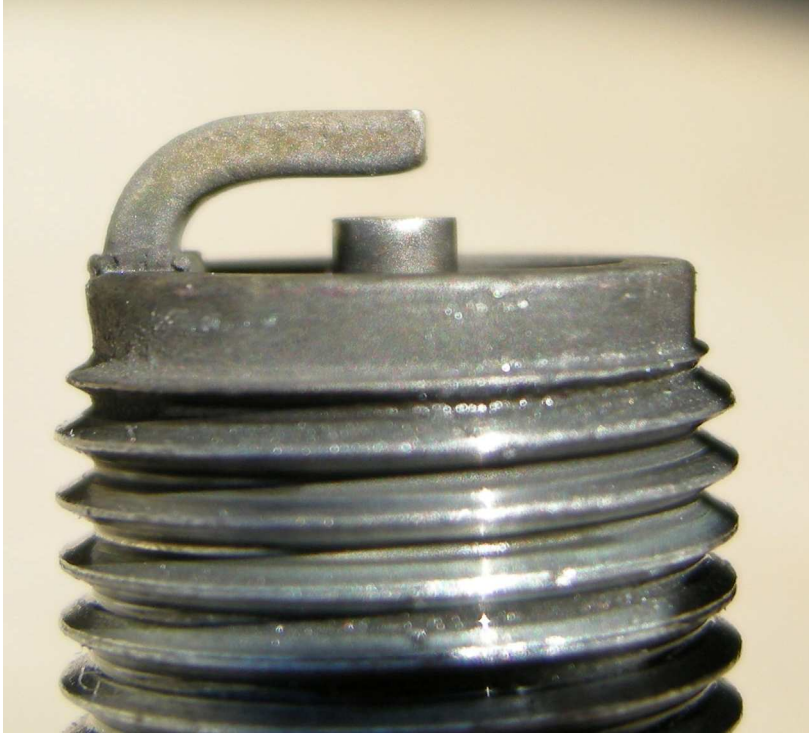
This photo identifies electrode wear on the strap end. This is the same KB engine. All the plugs wore this way. The arc discharge is evident only at the zone where the wear is happening. What is happening in this engine is the arc is weak. Its fitted with a Mallory 4 amp magneto. That is way too small to give good ignition to a methanol engine on 25 lbs boost. Methanol is highly conductive to electricity. This causes a situation where the arc energy has to have enough rise rates to blast the methanol even if it's a liquid in the path of the arc. Once the arc has started to discharge, liquids will be vaporized but they still have to be heated to ignition temperature. That takes time, and by the time that has started to happen the arc has sufficiently ionized the environment and the ionized molecules are being blown out of the gap area towards the end of the strap electrode. This is a common direction for arc to be blown. The most effective part of the arc at ignition of the mixture in this example is the end of the strap that is being eroded. Erosion of the metal is actually like a flint gun. Metal particles are being sprayed across the gap. Erosion of the electrodes is not detrimental to the performance provided the plugs are changed before it gets too bad; this example is too much erosion for this engines ignition system. The engine was originally set at .026" gap and I recommended .016" to .018". This lower gap allows the ignition to pass amperage through the gap quicker and ignites the mixture with a sharper definite kick. Low amperage magneto's work best with small gaps. Generally a 6 amp magneto can run a .028' or slightly larger gap. A 12 amp magneto can run .036" or larger.

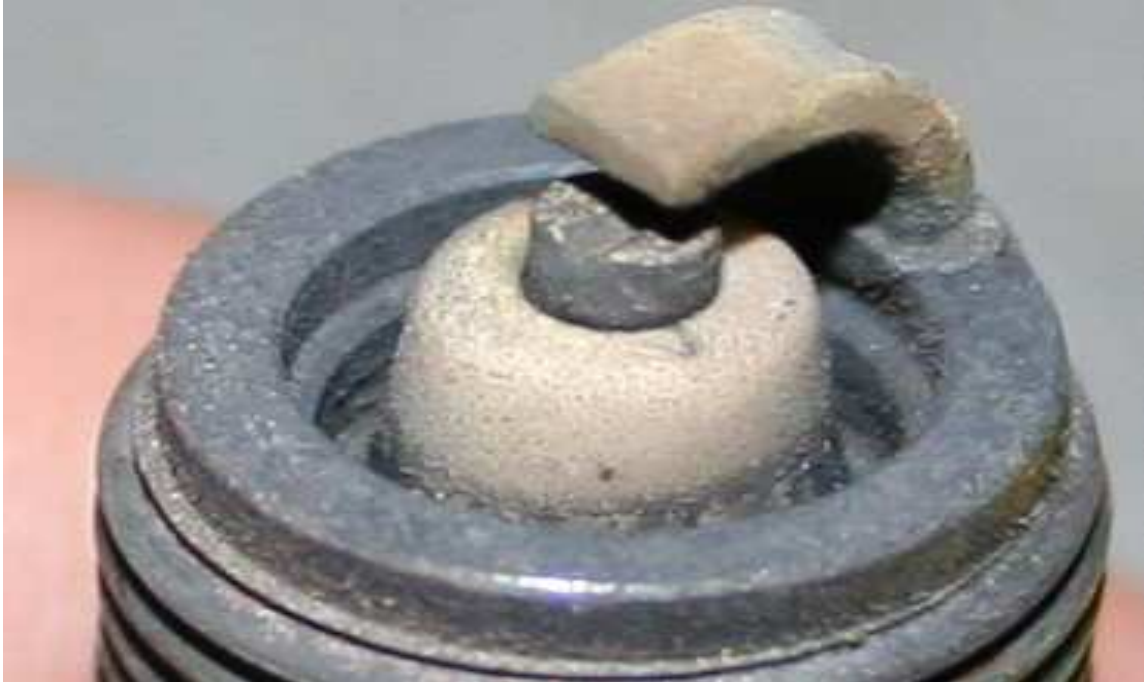
This plug is from an engine that has not enough compression of the chamber for the type of fuel. There is a lot of evidence of lead compound contamination. Lead compound contamination occurs when the temperature range of the area is below the temperature needed to activate the scavenging chemicals in the fuel. This engine is running VP 110 fuel and generates approximately 535 hp from 406 cubic inches. It looks like it's been in the engine for a long time but that is not the case. This engine quickly generates plugs like this. Note the erosion of the center electrode. This erosion will occur to this level in one run down a drag strip with this engine. The reason for the extreme erosion in this case is the lack of vaporization of the mixture at ignition time. If the mixture within the gap is under vaporized the mixture will ignite lean. The excess oxygen within the gap corrodes the metals there very fast.

The mixture of this engine is rich at lambda 0.85. The strap electrode is showing high levels of brown deposit. But there is not a matching level of brown on the porcelain. This is indication of differences in vaporization in the flame kernel area compared to within the chamber mixture. The chamber is always going to vaporize the mixture more than the flame kernel because the chamber has had more time and heat to achieve a higher vaporization level. The ignition system in this engine is a MSD digital 7.

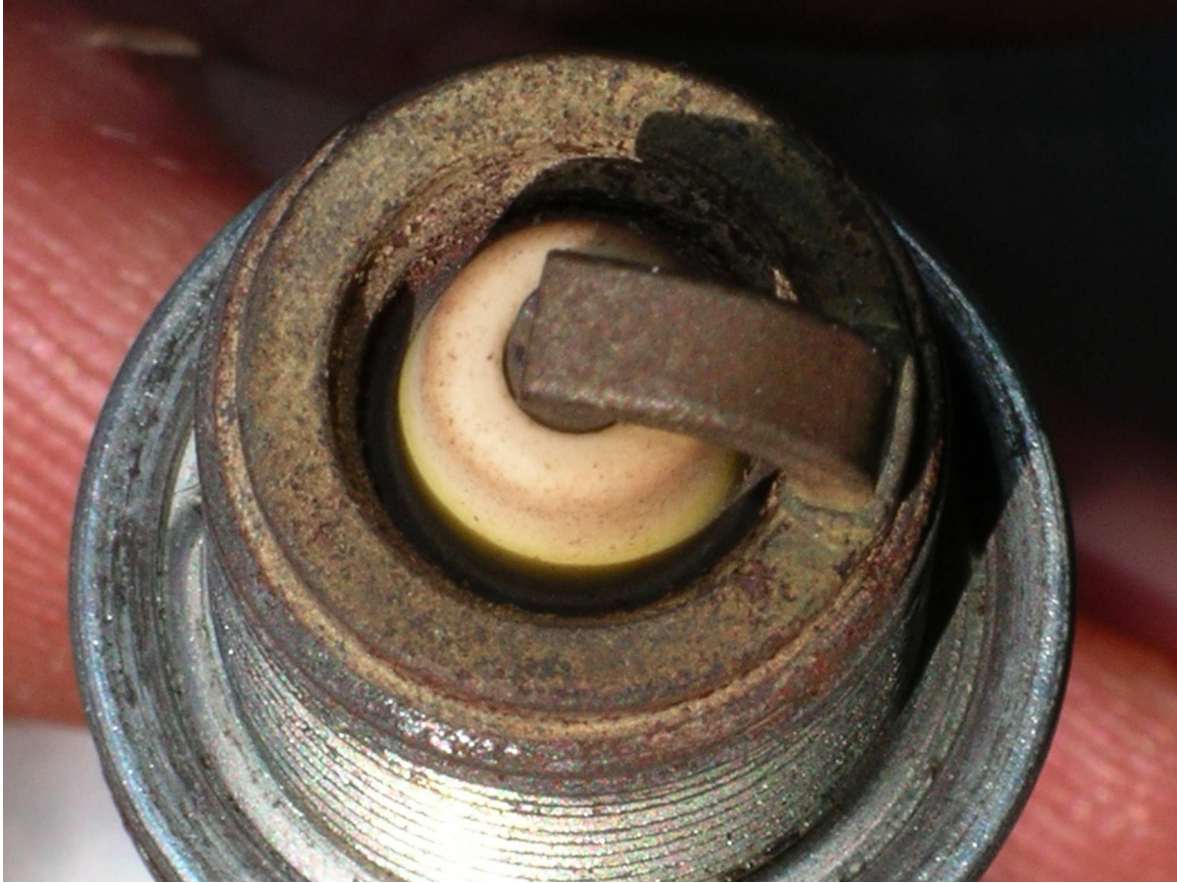
This plug is from an engine using 2* 1085 cfm 6 barrel SmartCarby carburetors. The compression ratio of this engine is 15.3 to 1 and the cranking pressure is 300 psi. Fuel is VP C14+ (a leaded fuel). The engine timing is 28 degrees. This is lambda 0.83. Note how the shell has Hydrocarbon deposits on it that are consistent with the strap electrode and the colouration on the porcelain. This is indicating a good consistency of overall mixture with possibly optimum ignition timing. It is a well vaporized rich mixture. There is no evidence of overheating..

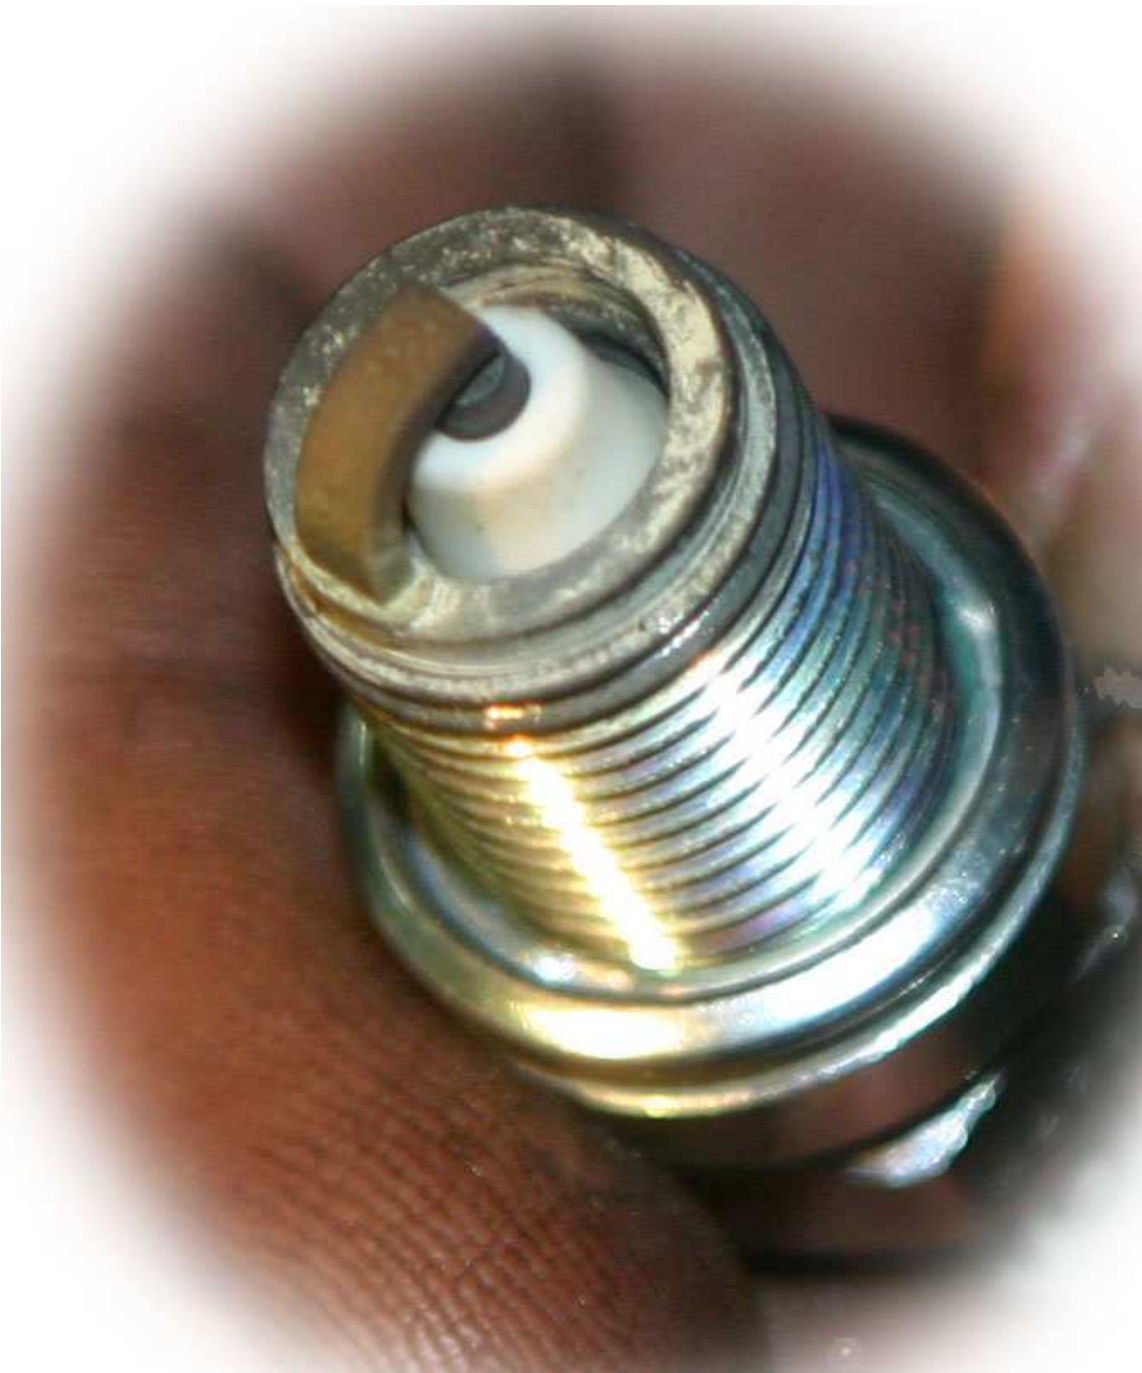
This plug is close to ideal but it's not right in some ways. This from the same engine as above but at lambda .87. But there is very little colour on the porcelain. This engine is using [SmartCarby](#) carburetion. 2 * 6 barrel 1085 CFM carburetors. You will notice the difference in deposit granule size by improved atomization. This is one drag strip run. After 4 runs the porcelain also slightly colored with tan, with the shell remaining clean. The cleanliness of the outer shell indicates close to complete hydrocarbon burn but the strap electrode indicates an excess hydrocarbon burn, (oxygen deficient). Clearly there is a difference in the mixture close to the head compared to further out in the chamber.

There is no evidence of overheating. The line on the strap electrode that is near the weld is sometimes interpreted by tuners to be evidence of the ideal ignition timing. The rule is often quoted as being to adjust the timing so that the line appears in the middle of the bend of the strap electrode. I do not agree with this theory. There is ample evidence from improved atomization style burns that this line exists only under some conditions and I have not been able to establish a link to the optimum timing degree. It is not as simple as that.

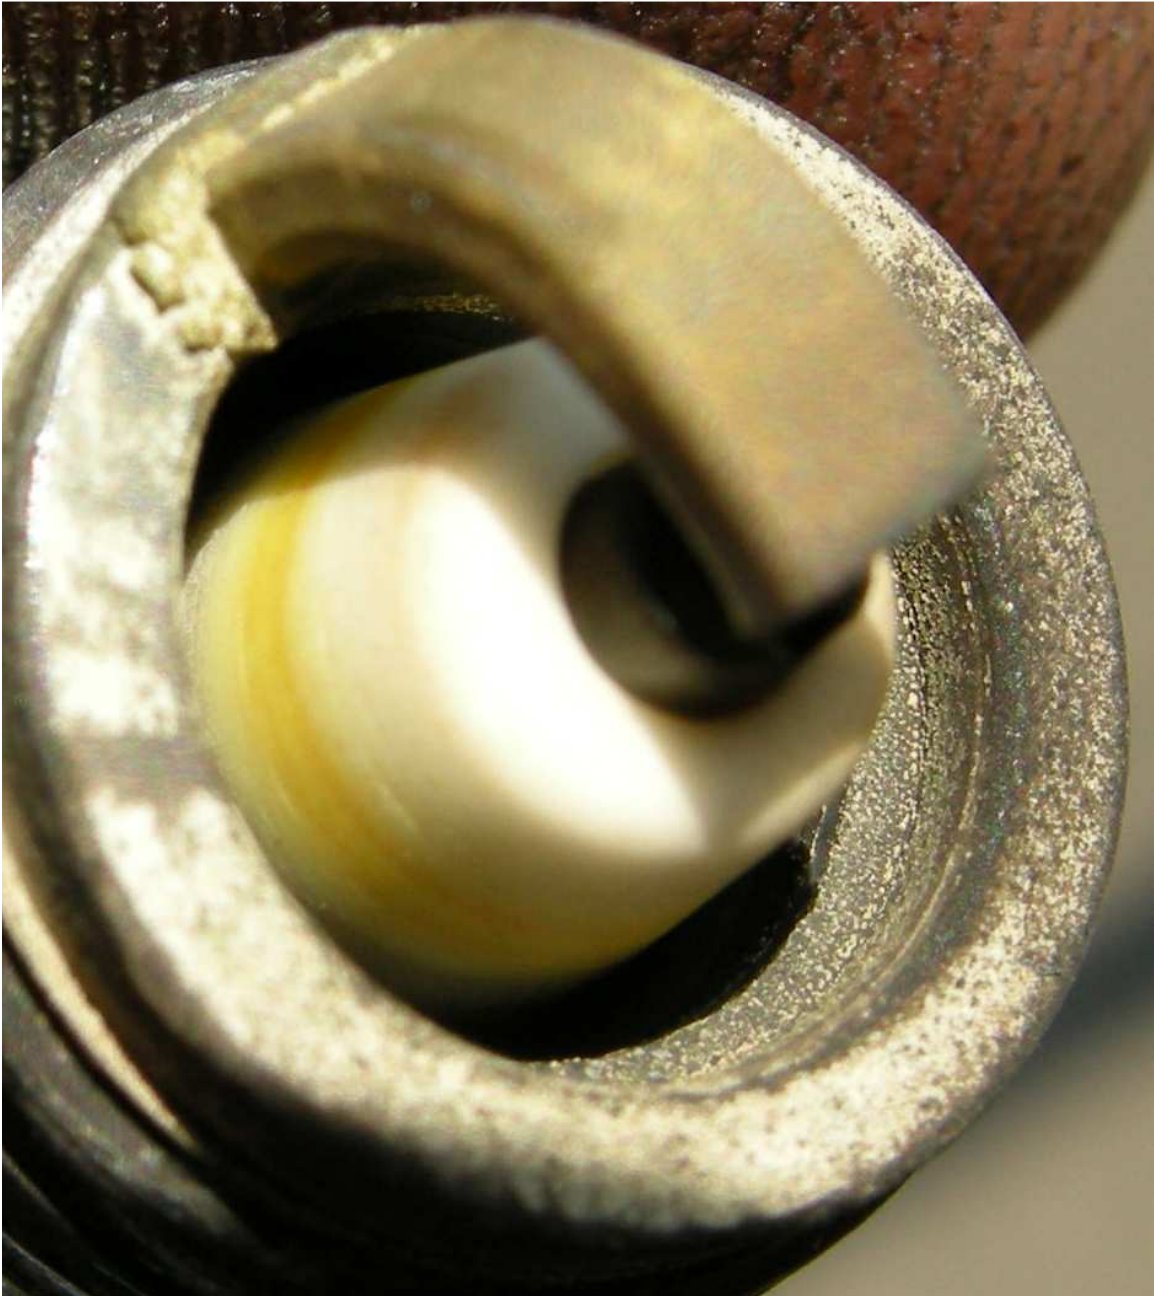
This plug is the same engine again but running 2*780cfm four barrel carburetors by SmartCarby. This is Lambda 0.87. This is one drag strip run. There is no grey at the base, indicating no CO. A good quality burn with low engine wearing characteristics. The

outer shell has consistent deposits throughout, water temperature is not an issue, the strap is nicely coloured with very even fine deposits. It's possibly a smidge lean, it might have been the air density of the day etc. It's nice to work with an engine like this. The lower CFM carburetors have altered the atomization of the fuel and the result is better temperature control even when slightly lean for the load and a more readable deposit within a short time giving readable results. The combustion temperature is probably high as indicated by the appearance of slight yellowing on the lower band and yet the strap is not stressed. I cannot provide information of the total fuel flow as there is no data logging of that on this car but it used significantly less fuel to achieve the same lambda as the first photo from this engine shown above.

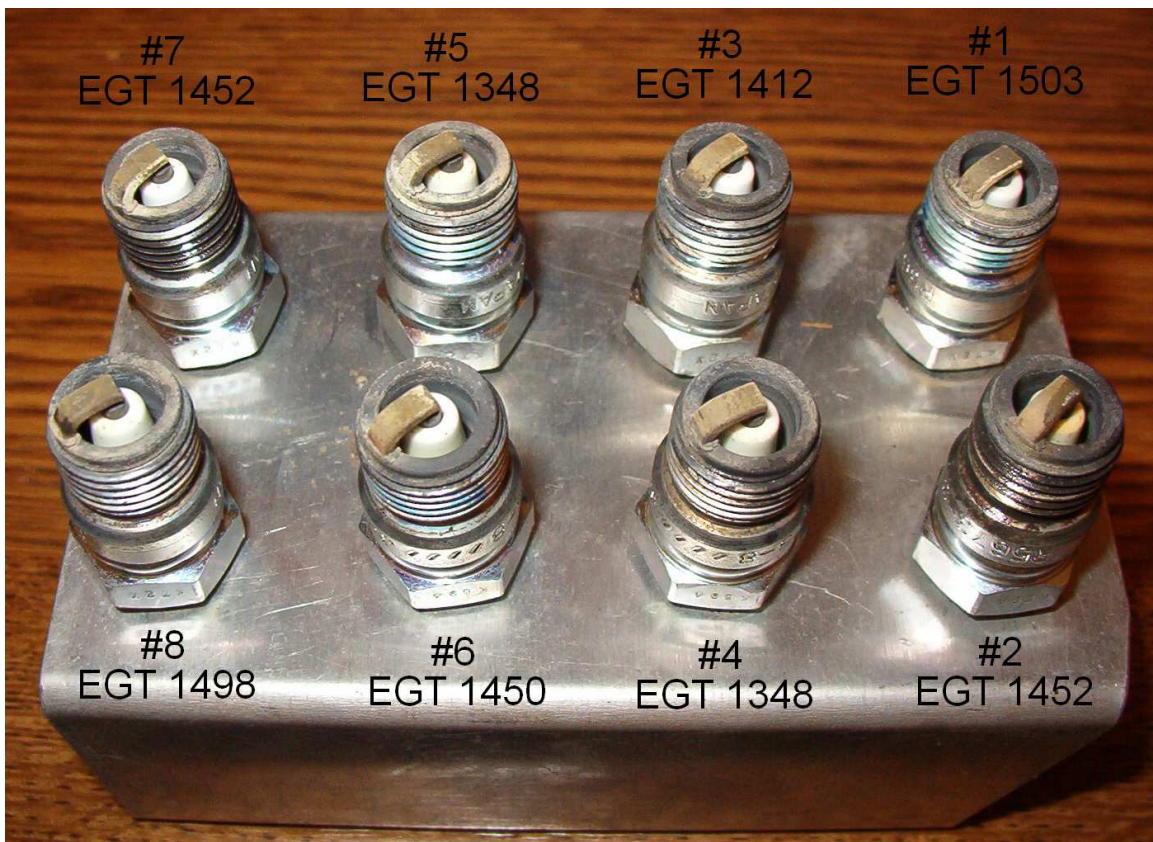
The plugs above show the irrelevance of correlating EGT to plug colouration.

There is no correlation between exhaust temp and burn sparkplug colouration. The ex temp is a measure of the wasted energy from the gases that managed to burn. The colour is the amount of carbon that burnt. That's why the caption reads what it does. These plugs are from a BBC that has a 1050 dominator on it and makes 530hp. It's a drag car. What this is an example of, is showing you that you can have different colours with the same amount of wasted energy. For instance 2, 6 and 7 are the same temperature and yet number 2 has colour. The brown plug and the clean plugs are the same temperature but you ask how come? Well the energy output of the brown and clear plugs cylinders is the same percentage of the fuel consumed. That's why you have to correlate information from different factors to correctly read an engine.

You can have the same power percentages of the fuel load of the cylinder with different fuel loads. Different fuel load make different power because of the relationships of CO and low temp versus CO2 and high temp. The brown plug cylinder has high CO and low temp slow burn. The cleaner plugs have lower CO and more CO2 and higher temp faster burns. The exhaust temp is a measure of the unused energy from the fuel that has been burnt so the mechanical conversion of energy lowers the exhaust temp. If the temps are the same but the plugs look different then the power output from the cylinders will be different and that's exactly how that engine in the photo runs. It has jumpy AFR and rough running of the rpm trace. It's a fairly common Holley engine.

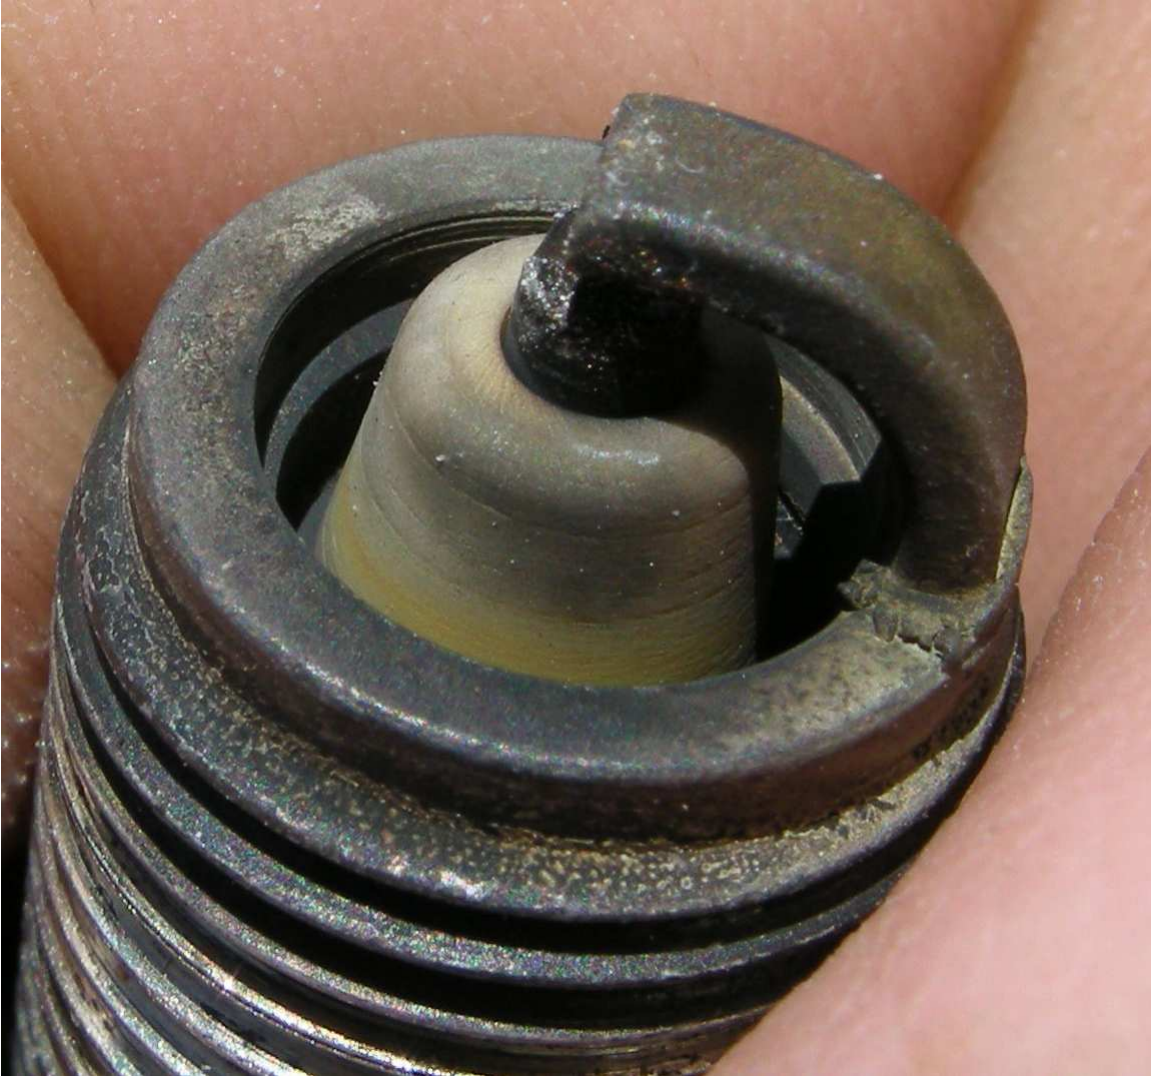
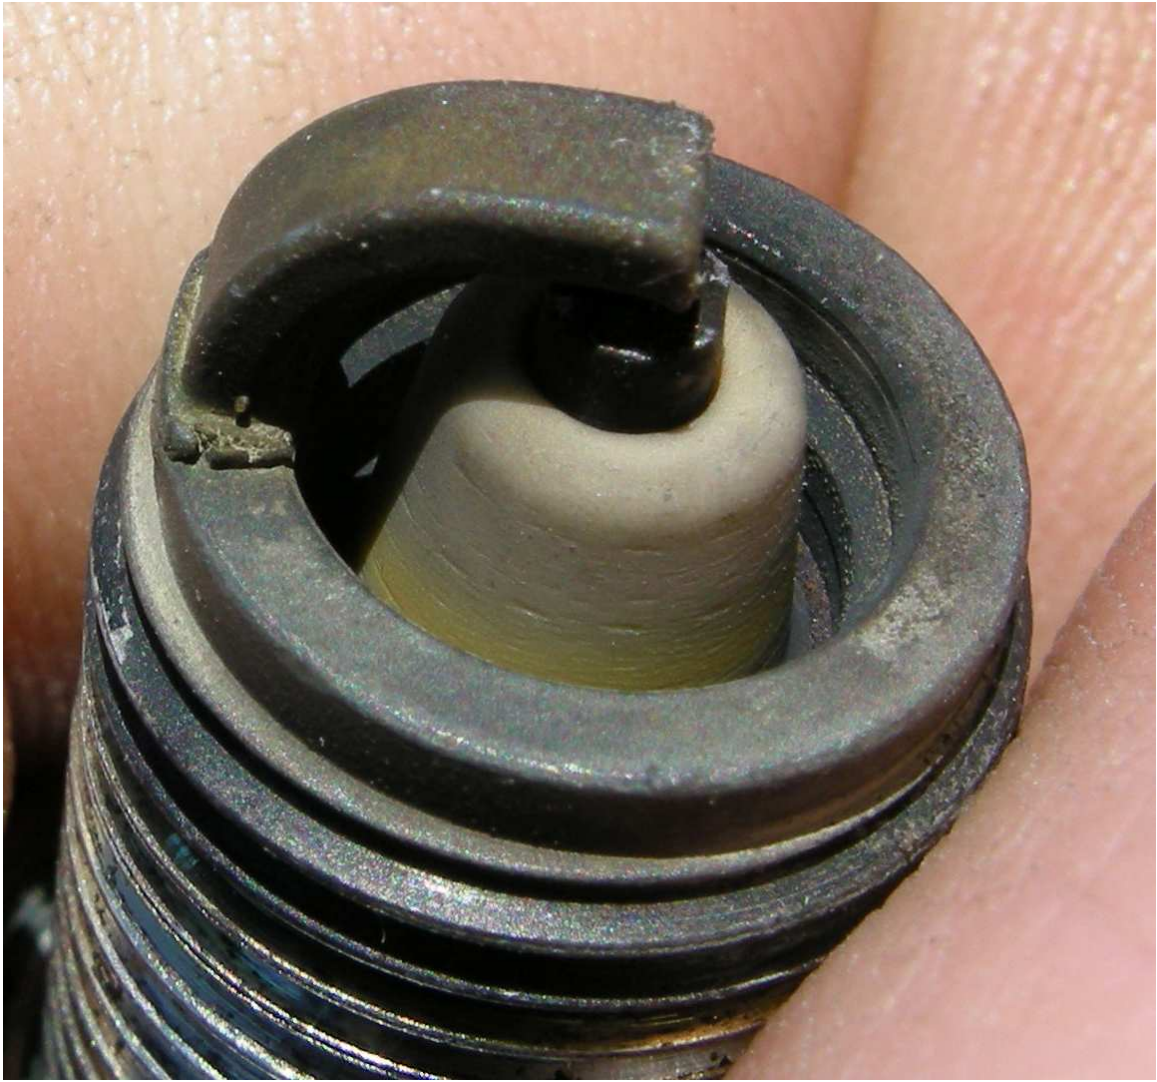
This plug is exhibiting arc blow. What is happening is the arc is being blown away from the electrode gap by extreme turbulence. You can see the arc blackness on the porcelain. The photos below is that plug from the other side. The index of the plug is such that the side showing in the photo below is facing the intake valve.

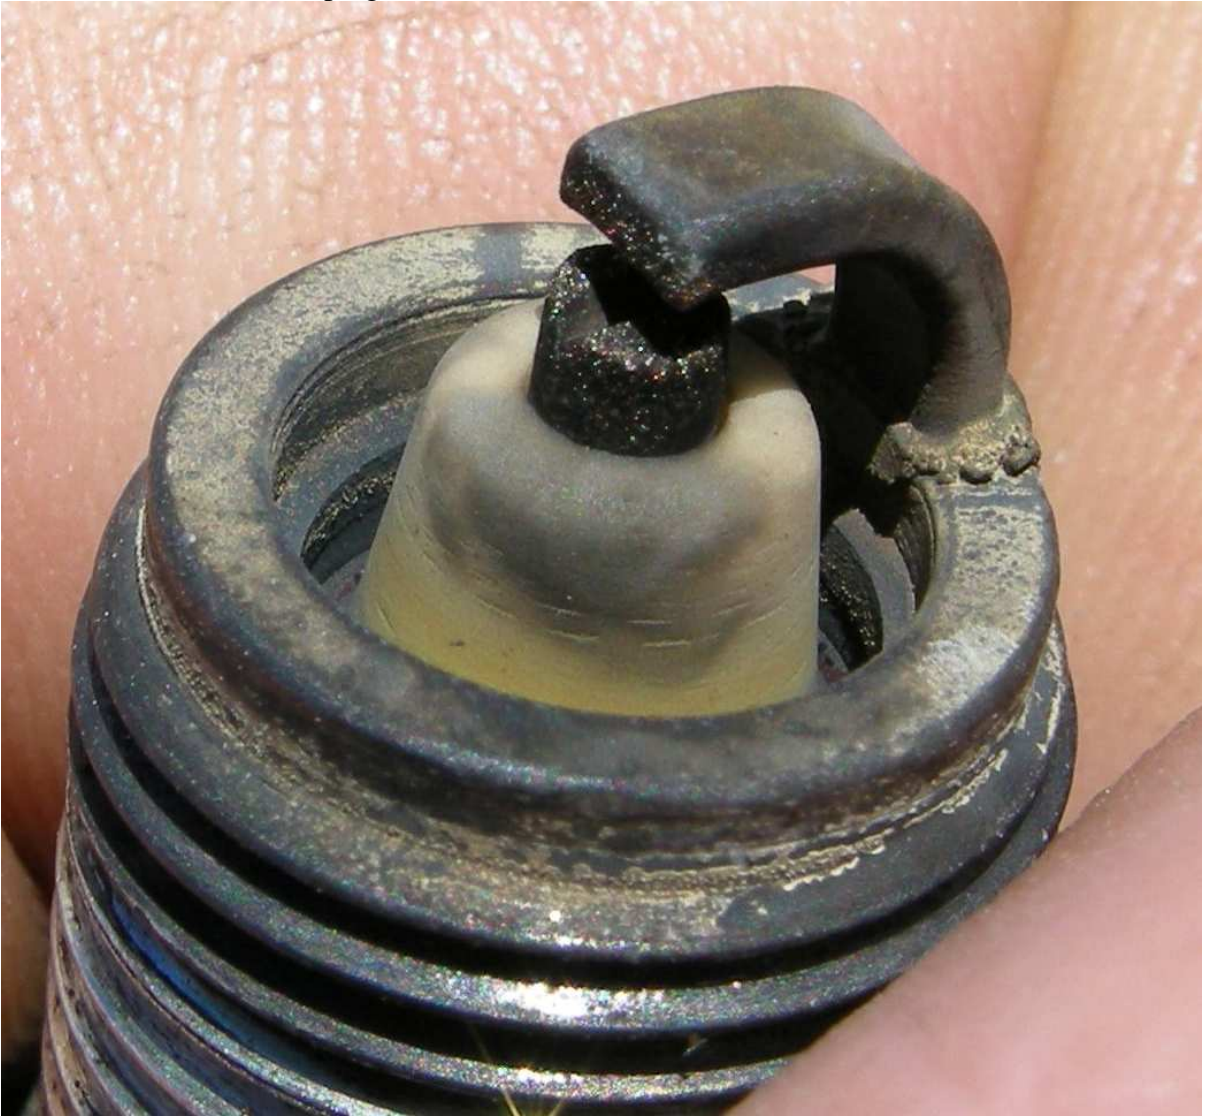
Here is another arc blow plug

It is easy to see the damage to the center electrode and that the arc is blowing out to the outer shell of the plug. The intake valve is toward the back side of the photo. You need a powerful ignition to achieve this level of arc discharge and not get a misfire. This is a MSD 10 plus ignition. The engine did not misfire when arc blow out occurred but it changed exhaust sound and lost some power.

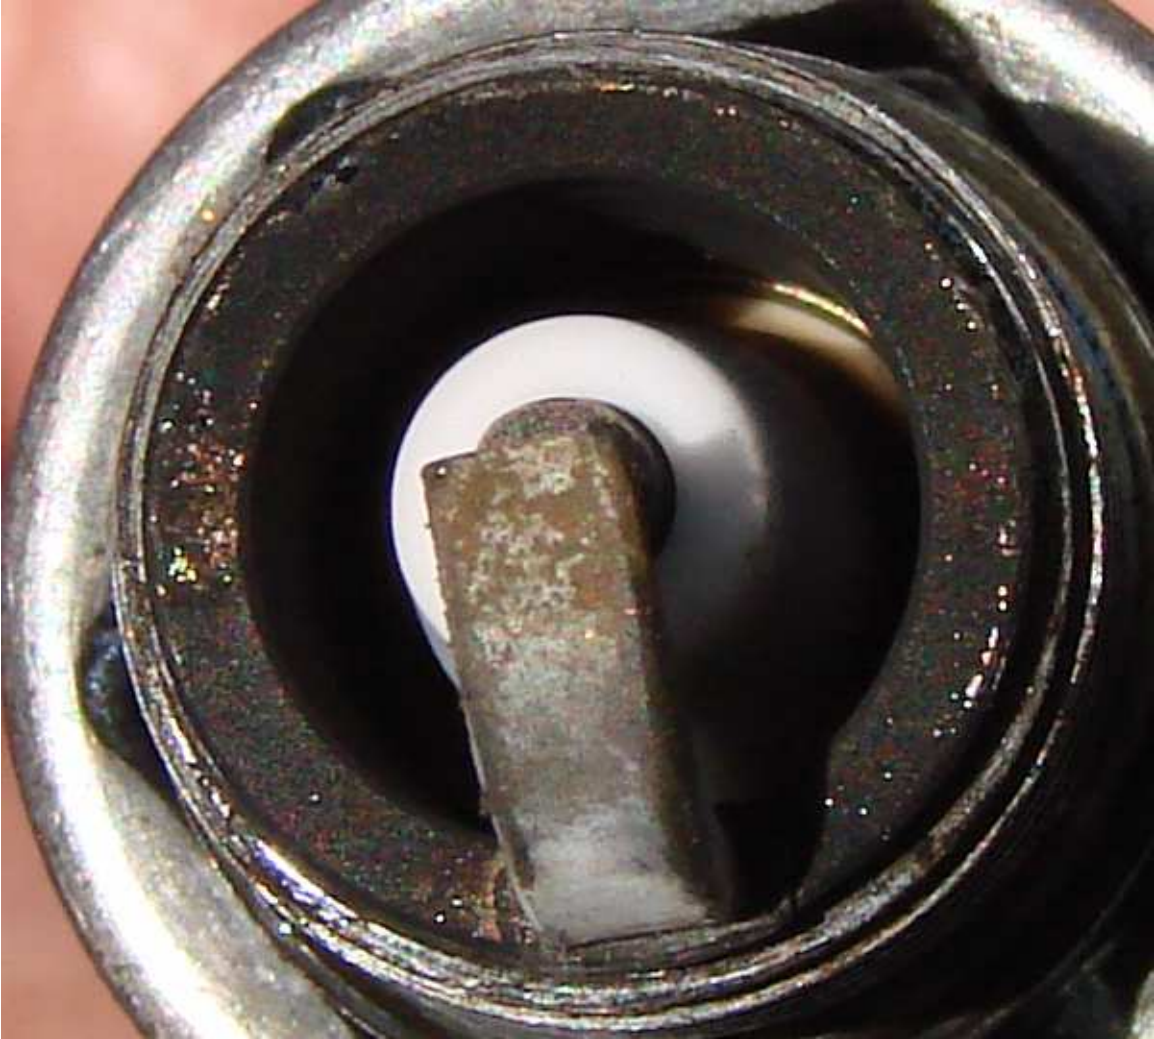
This plug is from a 308 Holden running unleaded street fuel. The engine made 153hp at the wheels. It had every ring broken on every piston; it had leaking valves and a smoke trail 3 feet long pouring out the breather but no smoke out the exhaust. You can see the tan colouration forming at the base of the porcelain and some tan specks starting near the 4 o'clock position near the roll on the top of the porcelain (its in the shadow a bit). But you can see tan easily on the strap electrode. The outer ring deposits are not soot and there is no evidence of oil combustion. The outer ring colors appear to be rainbow like but that's a digital camera anomaly, it wasn't like that to the eye. This picture shows what good vaporization can achieve on a stuffed engine. When using large droplets this engine produced oiled and soot covered plugs and blue exhaust smoke. So I retuned it for smaller droplets and it responded well.

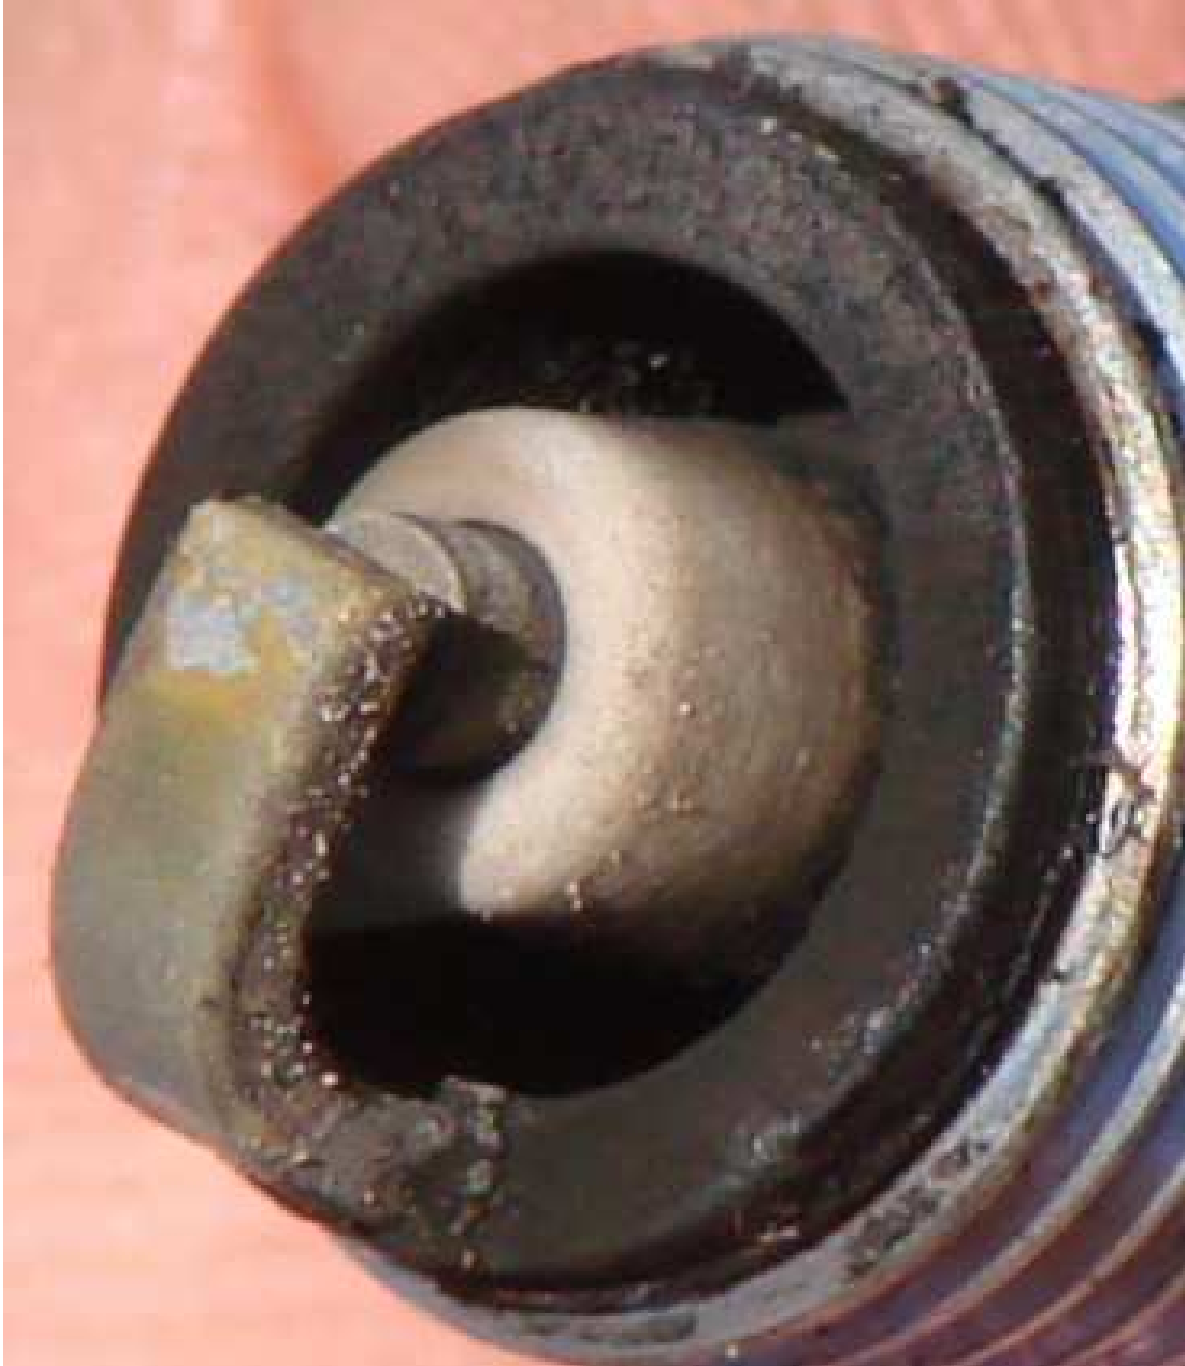
This is a plug from the same stuffed 308 but it's a high mileage general use photo. You can see the formation of tan graduating to dark grey at the base of the porcelain. This is unleaded street fuel. The mixture is leaner at the outer ring due to cruising AFR's etc.

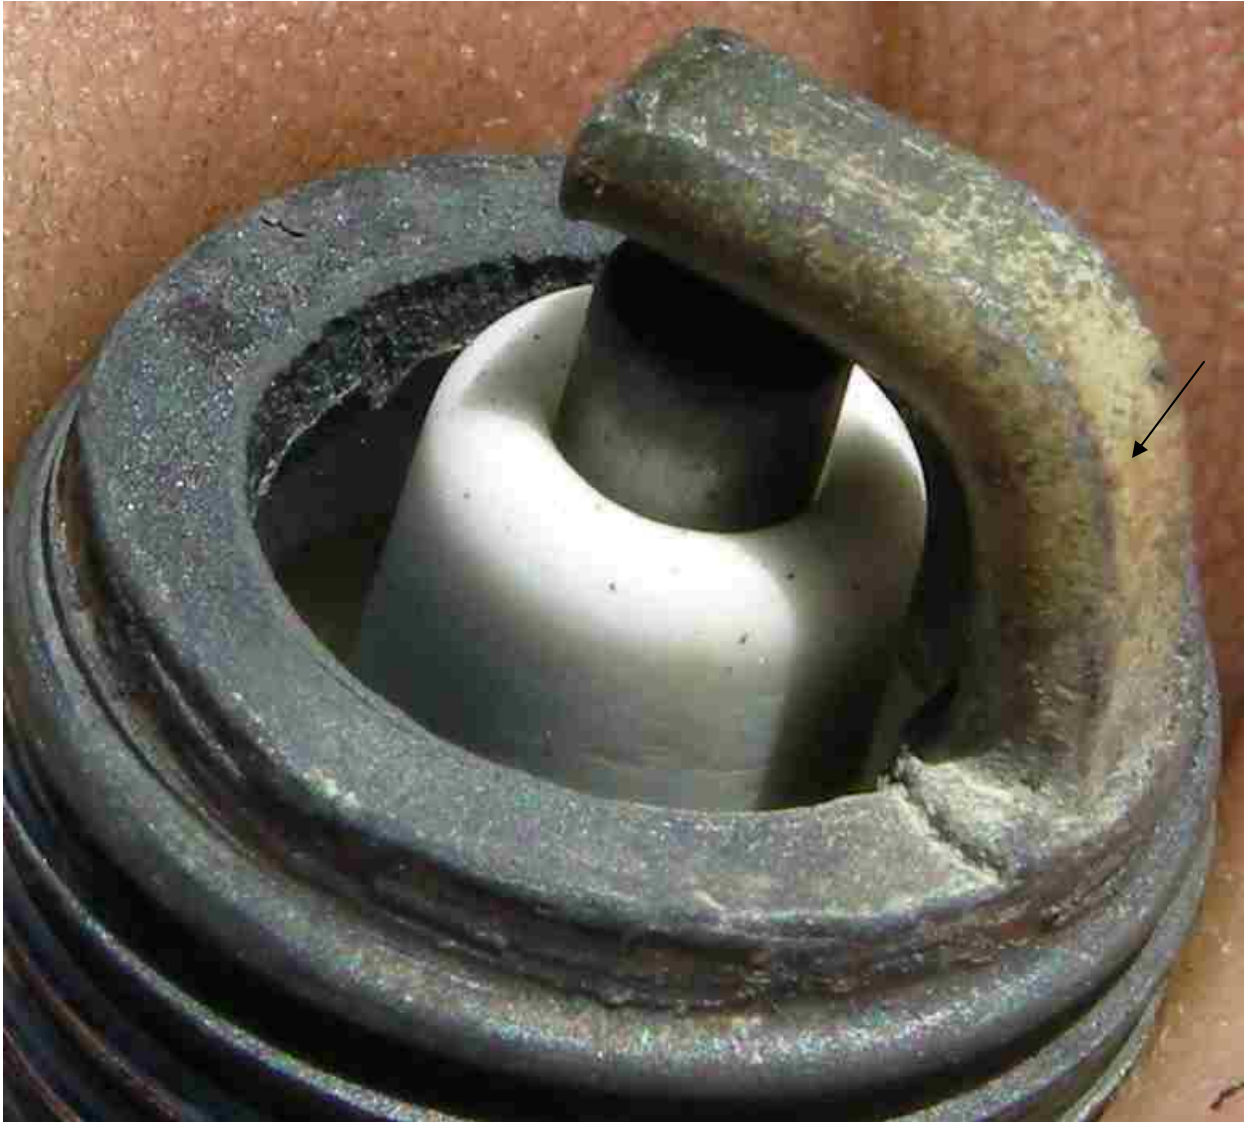
This plug is from a race engine running C14+, 15.5 compression ratio achieving 240psi cranking pressure. 1050 Holley Dominator. The Lambda of this burn is 0.78, that's quite rich and yet there is hardly any carbon deposit. Note the carbon built up on the inside of the shell, but its not on the porcelain or strap etc. These racers try to run their engine with cold water temperature. The carbon is building on the water cooled areas. The black spots on the porcelain are not detonation dots they are small flecks of loose carbon blowing off the shell etc, you can see that clearly with eye piece magnification. Note the surface appearance of the porcelain around the exit point of the center electrode; it is nice and smooth with no roughness.

See the little black arrow on the picture that's pointing to a brown spot, you cant see it on the camera resolution but in the center of the brown dot is a small area of cleaned metal that has been blasted away by detonation. Now bear in mind that this is very rich and the timing is 34 degrees. The timing was advanced further earlier in the day and it made more power but it was more serious detonation. After this test I richened it two jet sizes and the picture below is the result.

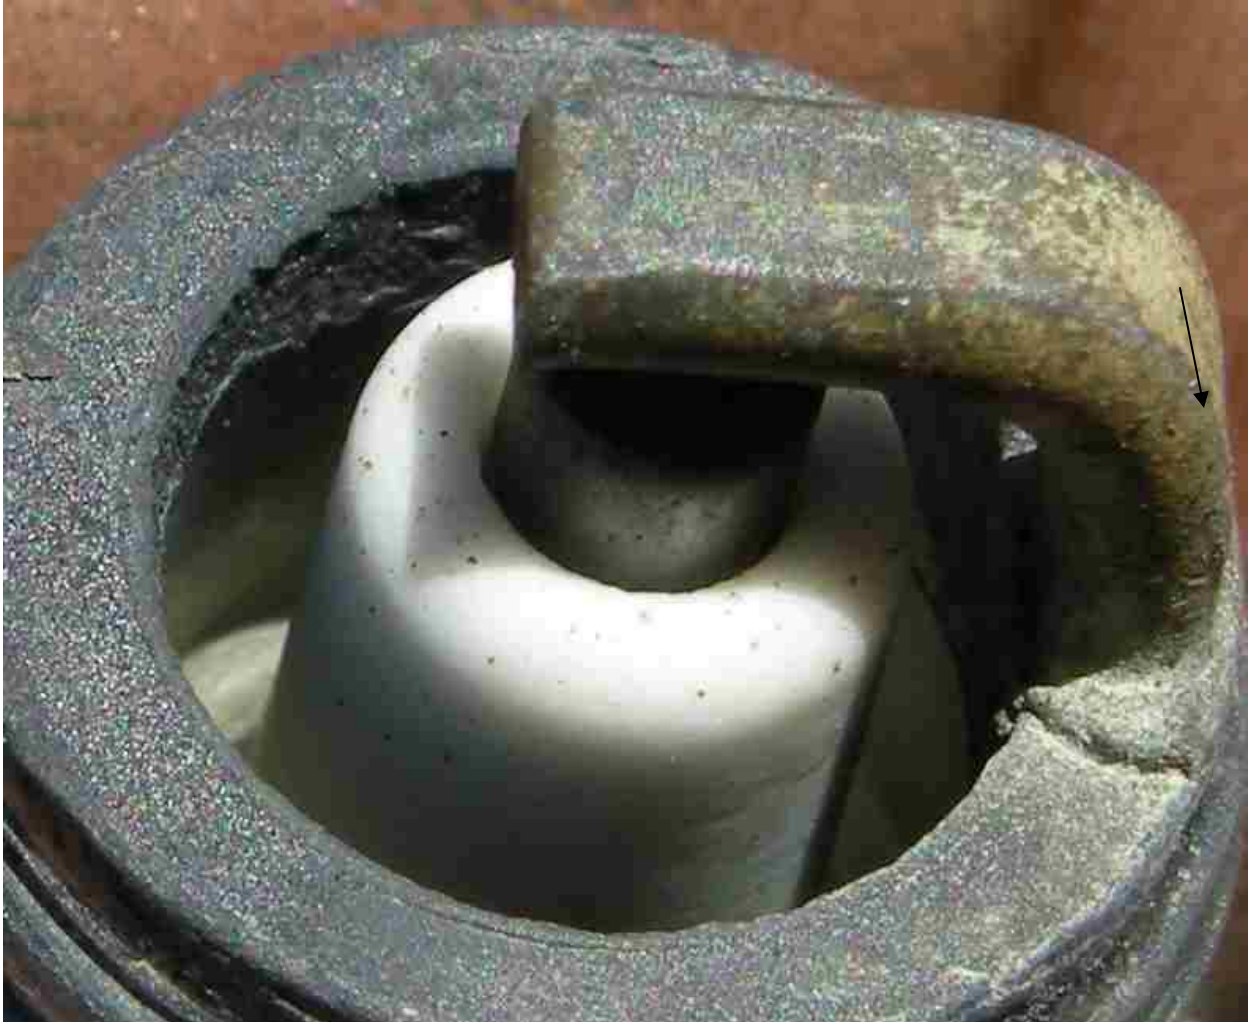
The same plug after one dyno pull of richer mixture. It made more power. The tan spot has cleared up, there was no evidence of blasted metal but the porcelain has started to break down in the joint to the center electrode. You can see the depth of the carbon deposit on the shell easily in this photo. No matter how much fuel you chucked at this engine the plugs always read like this, even when it was over fueled that much that it lost 40kw. It lost power running leaner, it has combustion problems. It continuously made extremely high CO and low CO₂ and had 4% oxygen left over. When I did the gas balance calculation on it there was the correct fuel for Lambda 0.87 and the Oxygen left over was exactly sufficient to complete a Lambda 0.87 burn. Observing the lack of carbon on the plug informs you that the environment at ignition time is lean and therefore the vaporization is low. The flame kernel is therefore slow growing, hence the increase in power with more timing, but the fuel octane wasn't enough to prevent detonation under those pressure conditions at that lean ratio in the vicinity of the plug. The strap electrode doesn't exhibit heat or anything else detrimental and C14+ is 115 octane fuel so what are you going to do to fix the issues? The real problem with this engine is the lack of energy input to the fuel up until ignition point, if there was more energy input there would be more vaporization and a richer environment and it wouldn't detonate and the plug would get carbon on it.
